USAFA-TR-78-11

**ENVIRONMENT, DISASTER, AND RECOVERY:
A LONGITUDINAL STUDY OF THE 1970 GEDIZ EARTHQUAKE
IN WESTERN TURKEY.**

NOV 1978

FINAL REPORT

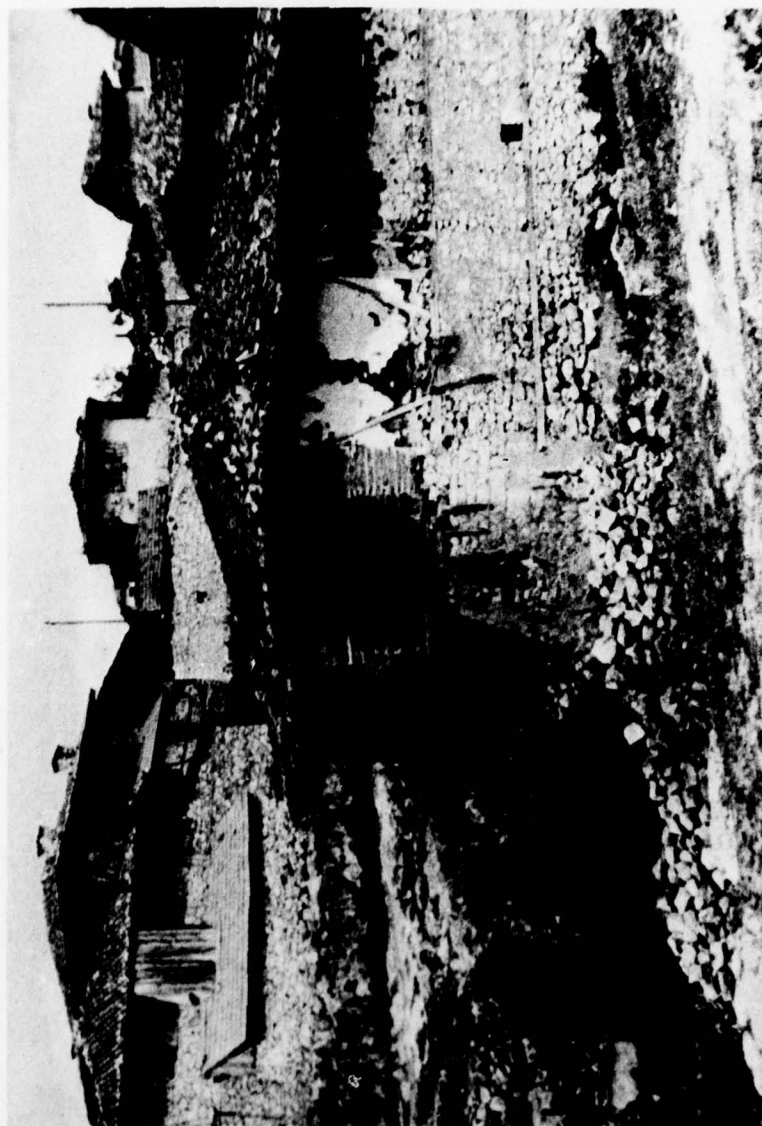
Figure 16

The fieldstone/mud adobe buildings suffered the worst damage of the disaster (Figure 16). Round-post timber construction also received heavy damage with sawn timber frame construction fairing much better (Table 13).

Fieldstone/adobe wall-bearing construction
such as this suffered the greatest damage.

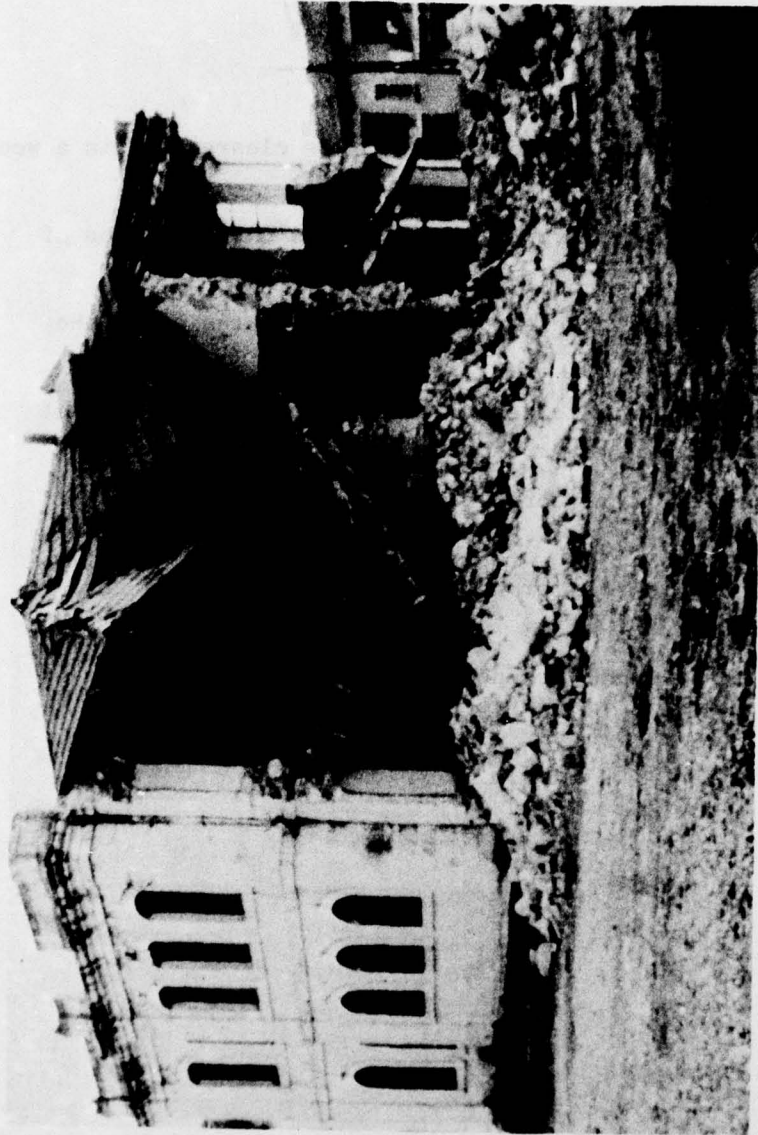
FIGURE A-1
A Destroyed Government Building

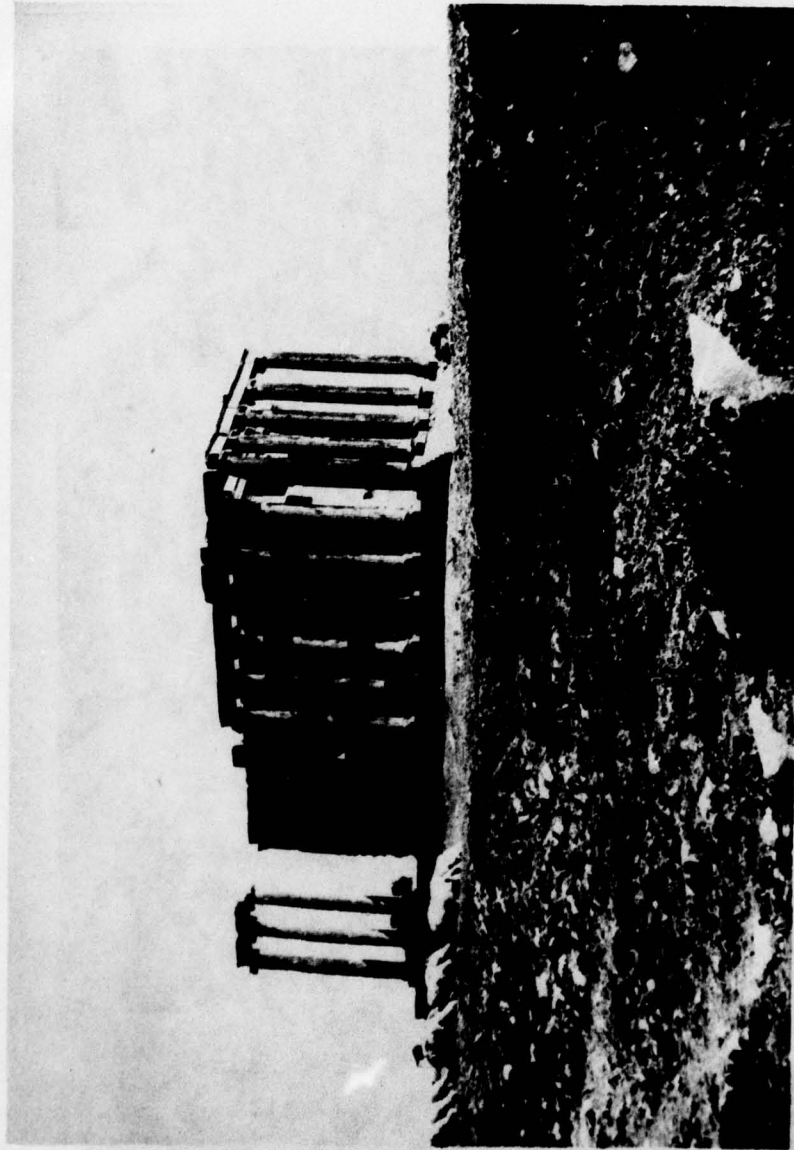
Many cultural structures were also damaged by the quake. Most of the mosques within Gediz and the surrounding villages were severely damaged, including the Gediz Ulu Cami which was built in the 15th Century by Mehmet Çelebi. Columns along the northeast corner of the Temple of Zeus, near Çavdarhisar, also fell (Figure A2).

FIGURE A-2
The Temple of Zeus
